Frost resistance of natural stones – a case study from Finland

Nike Luodes, Heikki Pirinen, Rossana Bellopede and Olavi Selonen

KIVI - STONE FROM FINLAND

Geotechnical report 13

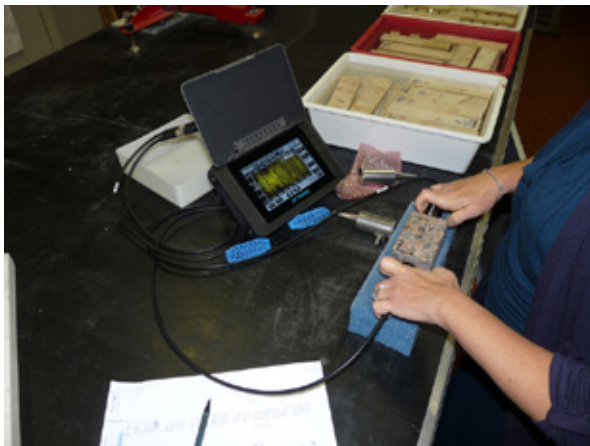
Figure 4. Ultrasonic pulse velocity (UPV) testing. Photo: Rossana Bellopede.

fresh material and on the same samples after 56 cycles of frost salt (Fig. 4).

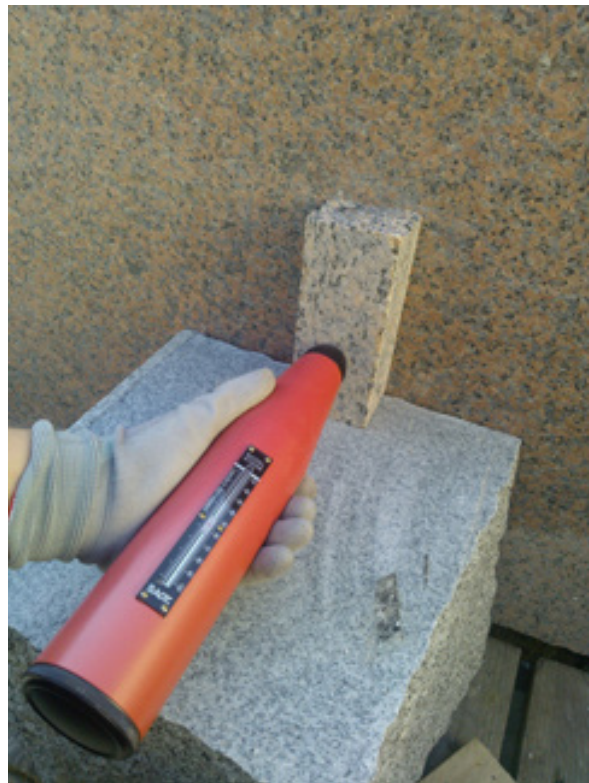
Figure 5. Schmidt rebound hammer instrument in testing position. Photo: Nike Luodes.

Schmidt rebound hammer (Fig. 5) test can be used to evaluate the weathering state of rocks in

Schmidt hammer tests were performed using a SADT Model HT225A hammer, performing three set of measurements of a chosen sample from the fresh and weathered material. Each set of measurement were composed by five horizontal rebounds per point, evaluating the average on the sample. The aim was to assess the surface weathering, also possible surface cracks, chipping, or rusting of the minerals. The test were performed keeping the instrument perpendicular to the vertically placed material (Fig. 5), as it had been used in previous site investigations on building walls by Luodes et al. (2014).

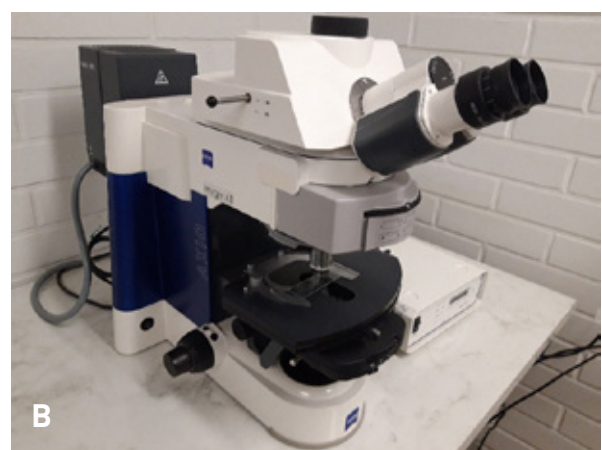
Figure 6. A. Analysis at the Scanning Electron Microscope (SEM). Photo: Nike Luodes. B. Optical fluorescent microscope. Photo: Akseli Torppa. Equipments in the GTK Mintec unit in Outokumpu.

Scanning electron microscope (SEM) was used in some cases to measure the dimension of the cracks (Fig. 6A), but the picture of the material got did not allow to distinguish open and accessible cracks from closed ones. In this case, the section of 15 mm x 25.5 mm was divided into five vertical sections and 17 horizontal measuring lines, and a total length of 255 mm in one direction and 127 mm in the other direction was tested. The results can also be affected by sample preparation and by natural variations of the material.

Optical fluorescent microscope Zeiss Axio Imager A1 was used for counting open cracks (Fig. 6B). Thin sections of approx. 20 mm x 35 mm were prepared with addition of a fluorescent substance. Methodology adopted was based on the one used in the Swedish Cement and Concrete Research Institute CBI for crack frequency. The methodology aims to distinguish material that might suffer weathering from those who might not suffer. The methodology consisted of the count of vertical and horizontal cracks on the thin section along a line of 100 mm in each direction along an imaginary grid. Results are expressed as cracks/mm, and 40x magnification was used. The procedure also evaluate the presence of intergranular cracks
